## "SOME OUTSTANDING QUESTIONS ABOUT THE *ESTONIA*".

Paper presented by Anders Björkman the 27 October 1999 at the 'Debate on the *Estonia*' of the "DESIGN FOR SAFETY" CONFERENCE of the Ship Stability Research Centre, University of Strathclyde.

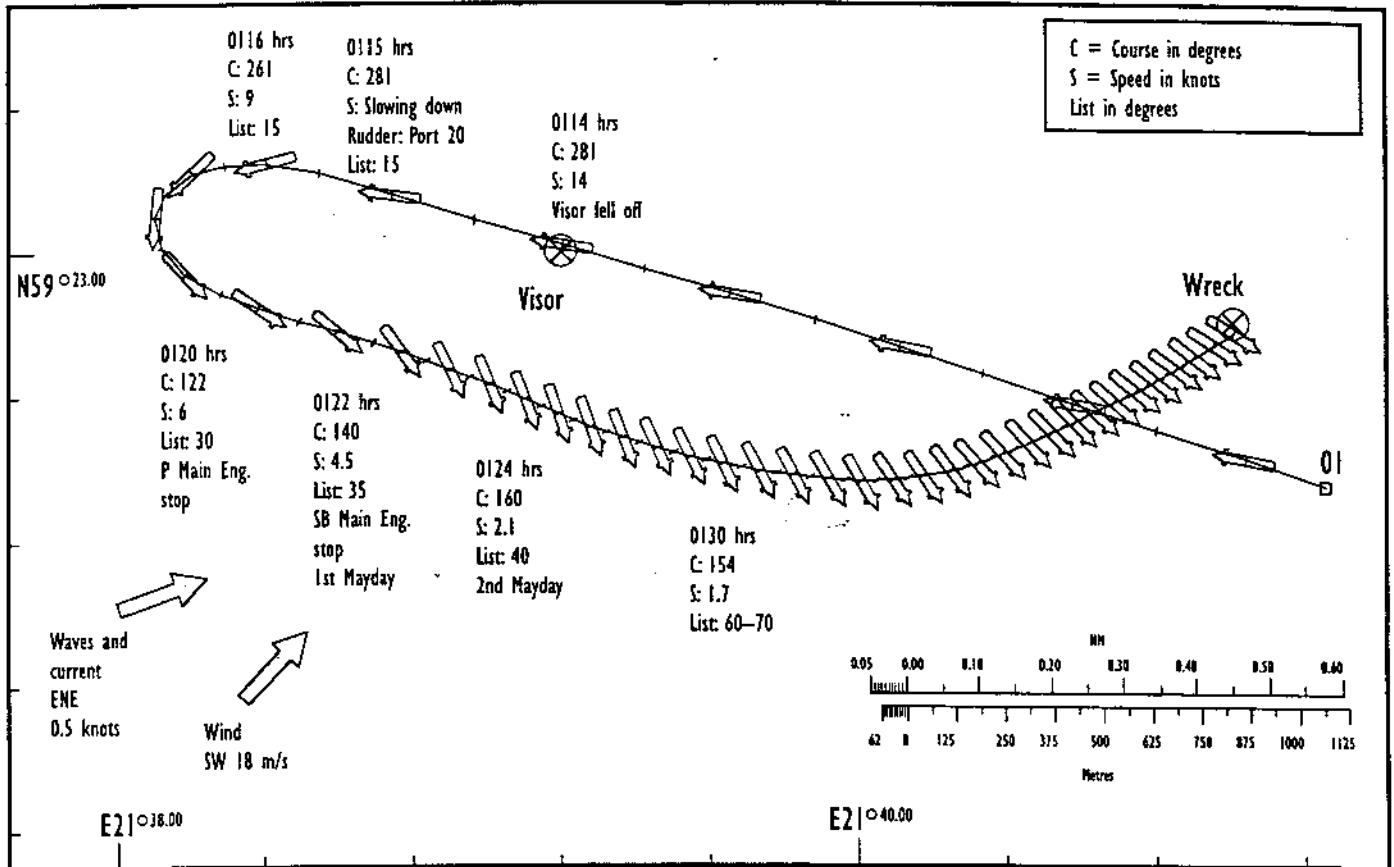
Figure 13.2 - Course of events - of the Final Report is shown below: -

Figure 13.2 in the Final Report is a sloppy modification of figure 4.12 in supplement no. 522 to the Final Report by Michael Huss, Ph.D., – 'Simulation of the Capsize', which in turn was a theoretical failure trying to reconstruct the accident by the Marine Academy of Kalmar. The modifications concern, i.a. the angle of heel and the amount of water on the car deck at various times after the visor was lost as shown in the below table: -

Expert Huss scientifically established based on model tests, *assuming that the ship turned 180° back to Tallinn first into and later away from the waves*, that it took 6⇒19⇒28 minutes to fill the car deck with 1,000⇒1,500⇒2,000 tons of water (inflow 166.7⇒38.5⇒55.6 tons/min). In that time the angle of heel increased to 22°⇒29°⇒37° (velocity of heeling 3.67⇒0.54⇒0.89 °/min). It took the *Estonia* 19 minutes to stop in the water at 01.33 hrs according to Huss. Then Huss calculated that the vessel, immobile in the water, scooped up another 500 tons of water on the car deck during 9 minutes (inflow 55.5 tons/min) and capsized at 01.42 hrs. Unfortunately it seems that Huss forgot to consider, that water on the car deck trims the ship - all the water would collect forward and push the bow downwards and increase the inflow, so that the ship would quickly stop, capsize and turn upside down - like the *Herald of Free Enterprise*. Another suggestion is that the water should have flowed out by itself due to the bow trim, when the ship stopped and that the ship would upright itself. However, the official investigation just changed the Huss reconstruction report completely, e.g. it first stopped the water inflow between 01.15 and 01.16 hrs to enable the survivors to evacuate the ship. Then more water was added on the car deck, but the trim was ignored. It is shown, without any scientific base, that the angle of heel increased to 40° in 10 minutes, to 60-70° after 16 minutes and to 110° at 01.40 hrs, as a result of allegedly increasing amounts of water on top of the car deck. The water on the car deck increased to 600⇒1,400⇒2,100⇒>4,000 tons of water in 2⇒6⇒10⇒16 minutes, but the ship's speed never stopped, even if the car deck was filled with > 4000 tons of water - the speed was 2.2 knots when the ship sank, which was physically impossible. Ships stop when filled with water and when the engines are stopped.

The falsification of the Huss data by the investigators is easy to demonstrate. Huss computed, based on model tests, that only 2,000 tons of water could have entered the car deck 2.5 meter above the waterline in 28 minutes. The average inflow was about 71.4 tons/min. Without any scientific base at all the official investigators changed the data and stated that >4,000 tons flowed into the car deck in only 16 minutes. The average inflow was >250 ton/min, which is more than 3 times the inflow rate from Huss model tests! According all model tests the inflow never exceeded 55 tons/min when the bow was pointing away from the waves and the speed was less than 5 knots.

Thus - Dr. Huss tried to reconstruct the accident with water on the car deck but his times did not tally with the actual sinking. According Huss the vessel should have stopped after 19 minutes and capsized after 28 minutes. However - the official report changed the times, heel angles and water inflow of the Huss report to tally with observed times and heel angles, but then the data do not make physical sense. In spite of the fact that the official report increased

the average inflow rate more three times, it took the vessel 37 minutes to sink without capsizing. The errors are obvious.

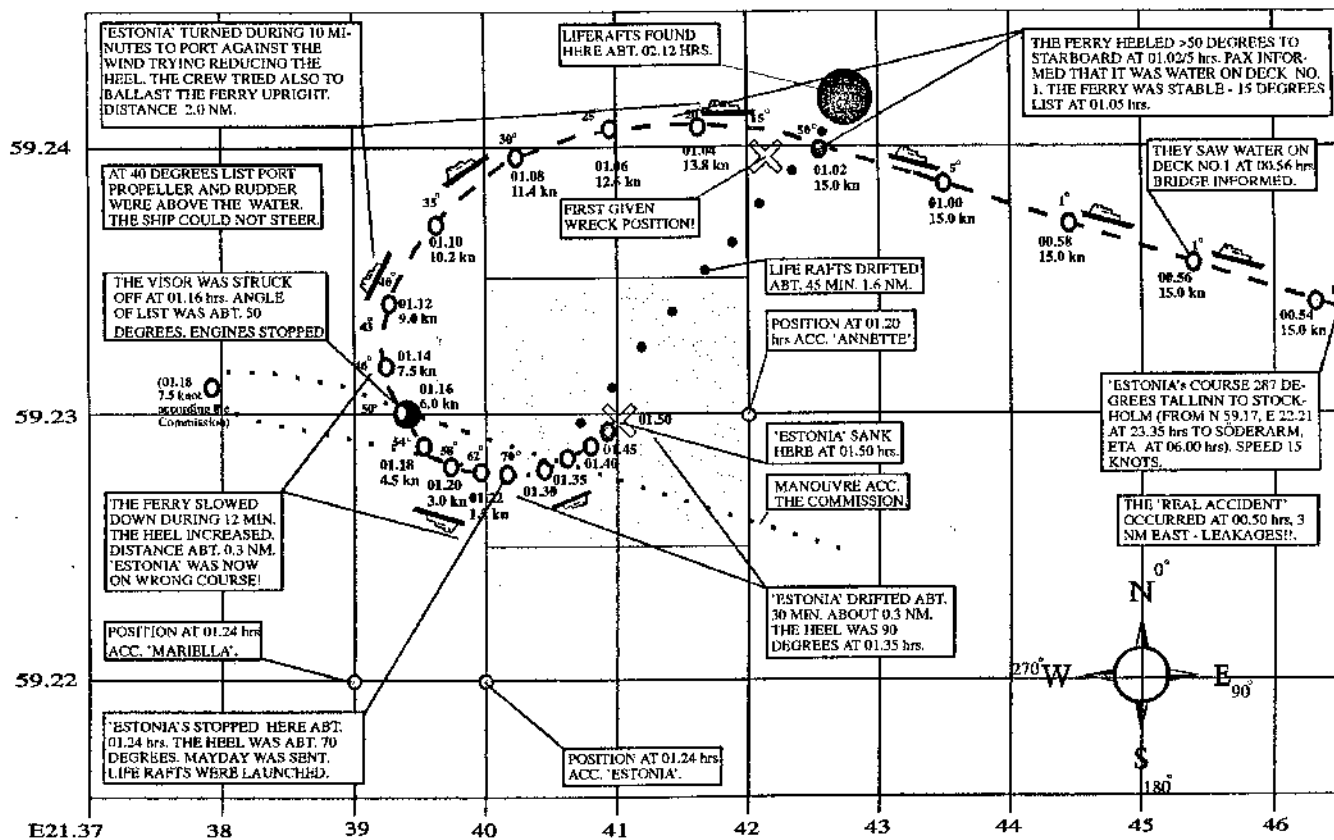
# M/S 'ESTONIA's LAST 60 MINUTES (reconstruction)

The course of events is shown in the attached reconstruction of the accident (page 10). The times, the positions of the visor and the wreck and the ship at 01.25/30 hrs, when Mayday was sent, and the turn to port between 01.02/25 hrs make sense. Also the timing of the sinking makes sense - the inflow of water through a hole below waterline was say about 150 tons/min and spread through open watertight doors to several watertight compartments below the car deck. After 30-40 minutes all buoyancy aft below the car deck was lost; the superstructure was immediately flooded so that the ship sank - stern first. The car deck was still intact and contained buoyancy, but it was not sufficient to keep the ship afloat.

The shaded one square mile around the wreck is the diving exclusion zone proclaimed by Estonia, Finland and Sweden and accepted by Denmark and United Kingdom.

© Anders Björkman, 6 rue Victor Hugo, F 06 240 Beausoleil, France. PLOT OF THE 'ESTONIA's LAST 60 MINUTES. Assumed angle of list shown over and to the left of the course. Local Estonian time (GMT +2 hrs) and speed shown below and to the right of the course. Wind SW, B 7.
