• **THE ESTONIA ACCIDENT**

**A short summary on the basis of the Final Report by the
Joint Accident Investigation Commission**

Tuomo Karppinen, member of former JAIC

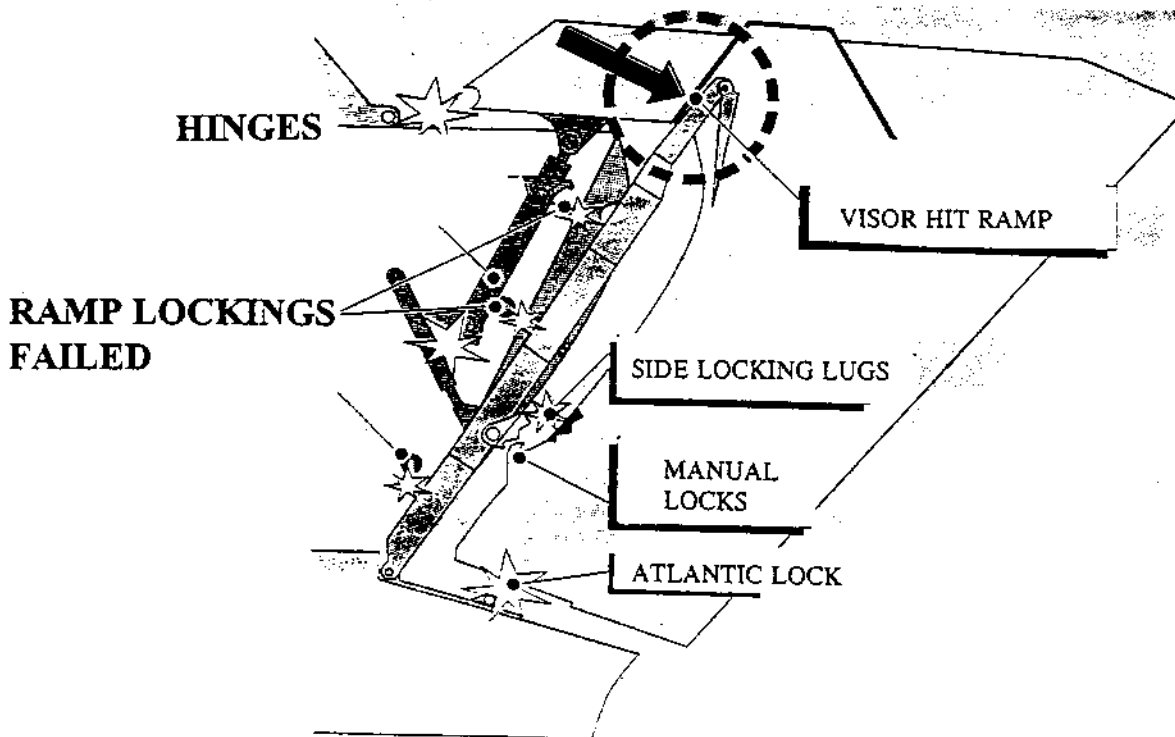
- WAVE IMPACT BROKE VISOR LOCKING DEVICES AT A LOAD LEVEL OF MAXIMUM 1.2 TO 1.5 TIMES THE DESIGN LOAD. OTHER VISOR ATTACHMENTS FAILED.
- VISOR HOUSING HIT RAMP UPPER END AND OPENED RAMP.
- VISOR FELL TO THE SEA AND LEFT RAMP FULLY OPEN.
- WATER ENTERED THE CAR DECK.

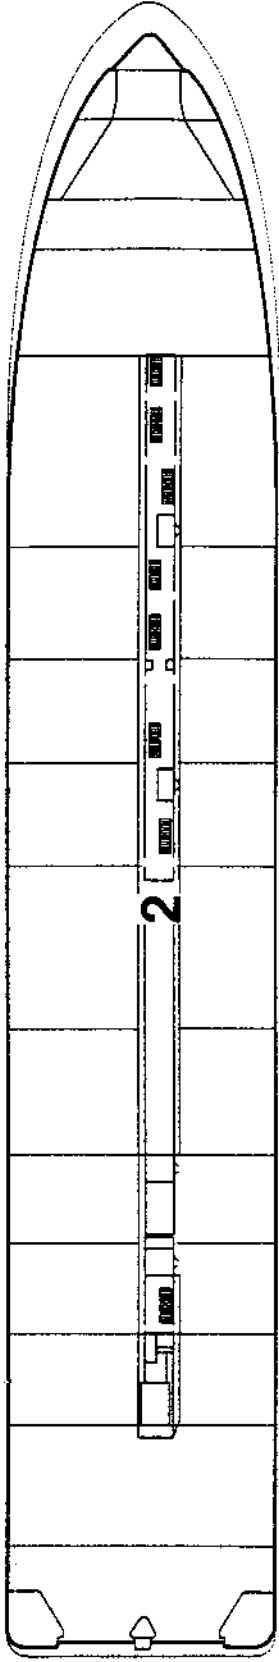
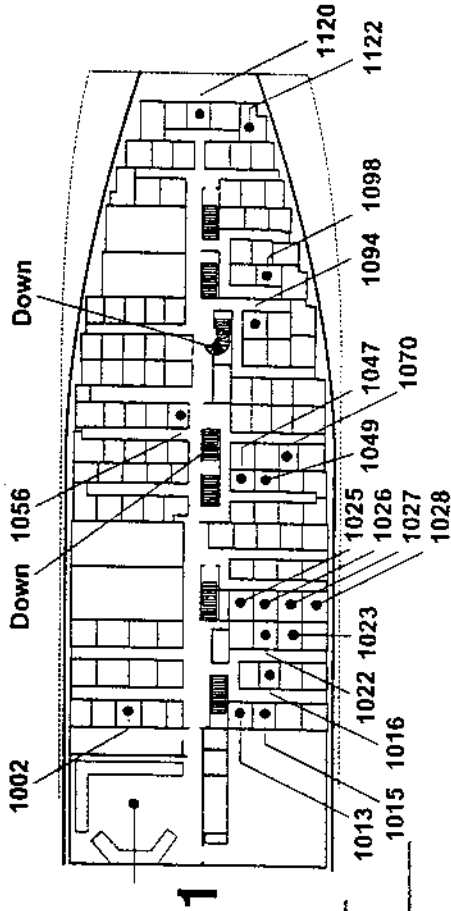
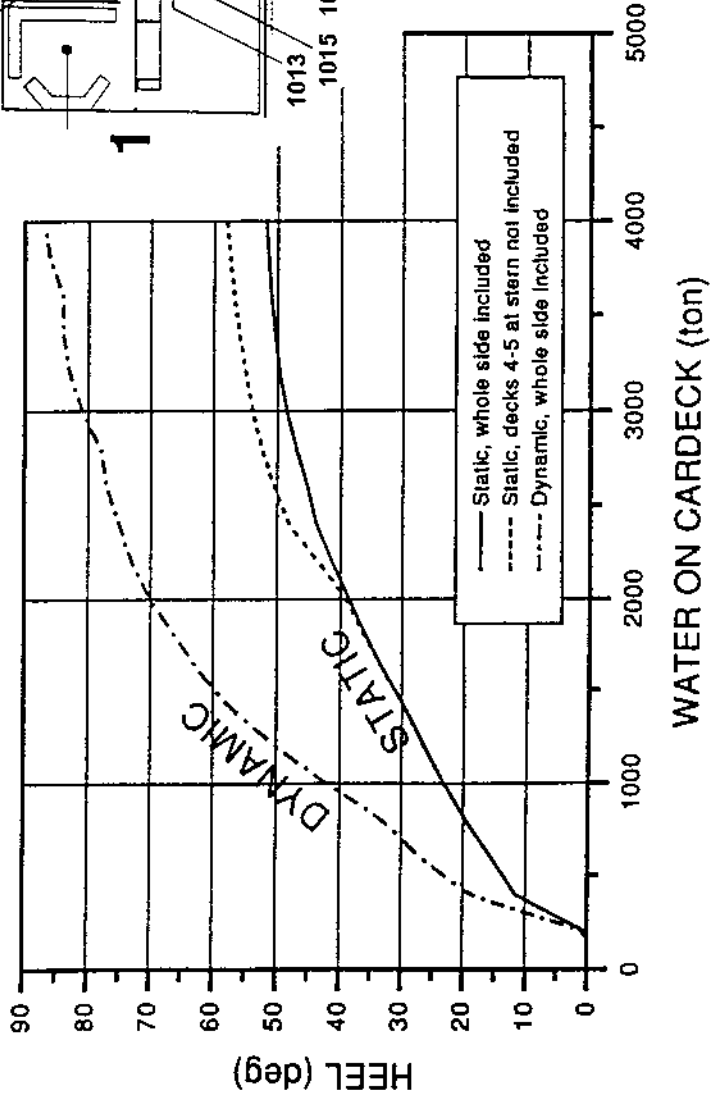
FIRST LIST ABOUT 15° INCREASING QUICKLY TO ABOUT 30°

water flowing on the corridor floor
a little water on the corridor
a thin trickle of water
water trickling onto the deck

**LIST DUE TO WATER ON THE SAUNA COMPARTMENTS
AND IN THE DECK 1 CABIN COMPARTMENTS**

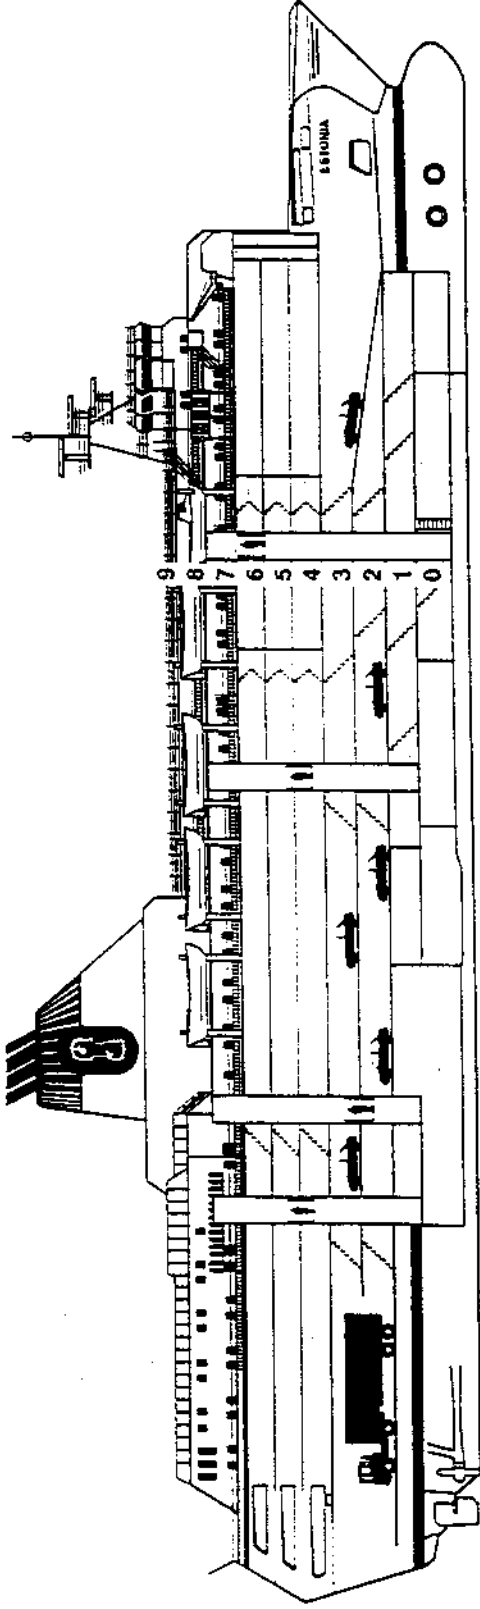
3 COMPARTMENTS ON TANK DECK FULL OF WATER

6 COMPARTMENTS ON DECK 1 PARTIALLY FILLED

WATER IN TOTAL ON DECK 1	LIST	TRIM TO BOW
435 tonnes	5.1 degrees	2.3 metres
1640 tonnes	12.4 degrees	3.6 metres
3280 tonnes	3.0 degrees	4.3 metres

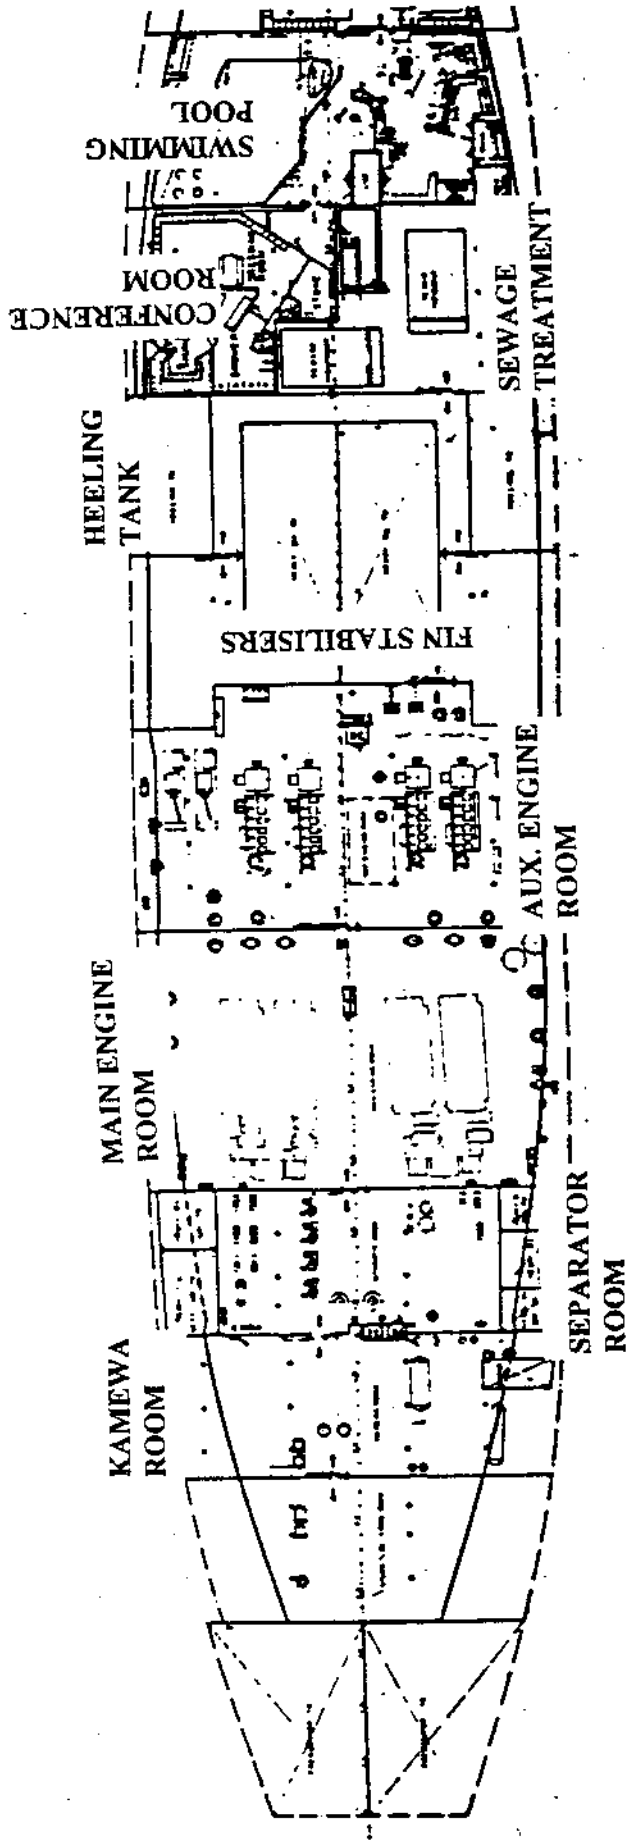
LIST DUE TO WATER IN THE ENGINE ROOM

WATER IN 7 COMPARTMENTS

WATER IN TOTAL	LIST
1505 tonnes	15.0 degrees
2320 tonnes	11.3 degrees
3010 tonnes	3.7 degrees

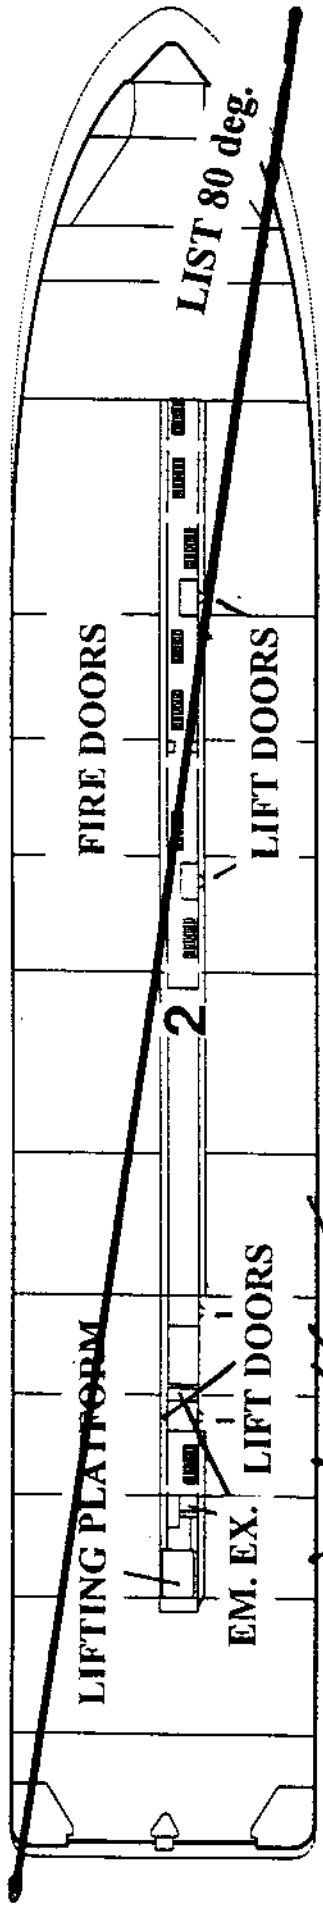
SITUATION AT ABOUT 0135 hrs WHEN THE CLOCK ON THE BRIDGE 3 m TO SB FROM CL STOPPED AND SURVIVORS WERE WASHED AND JUMPING TO SEA
