• **THE ESTONIA ACCIDENT**

**A short summary on the basis of the Final Report by the
Joint Accident Investigation Commission**

Tuomo Karppinen, member of former JAIC

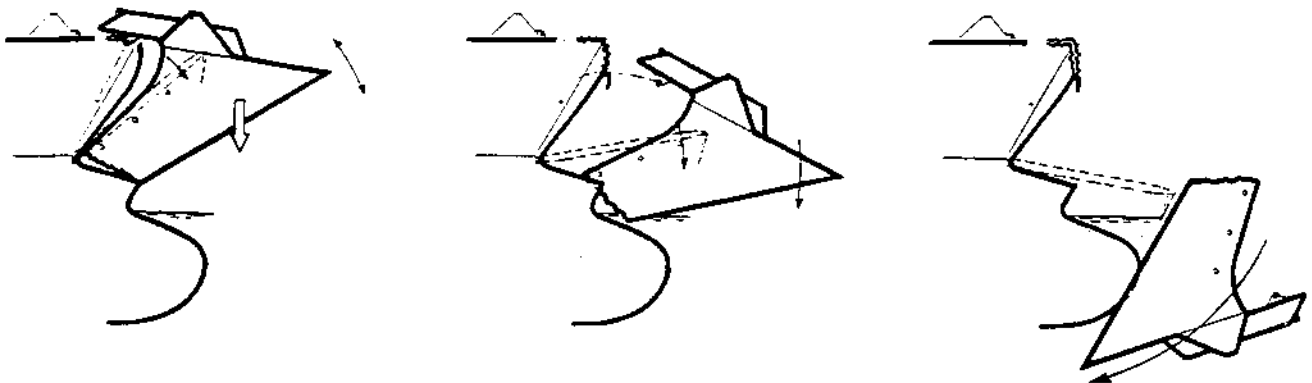
- WAVE IMPACT BROKE VISOR LOCKING DEVICES AT A LOAD LEVEL OF MAXIMUM 1.2 TO 1.5 TIMES THE DESIGN LOAD. OTHER VISOR ATTACHMENTS FAILED.
- VISOR HOUSING HIT RAMP UPPER END AND OPENED RAMP.
- VISOR FELL TO THE SEA AND LEFT RAMP FULLY OPEN.
- WATER ENTERED THE CAR DECK.

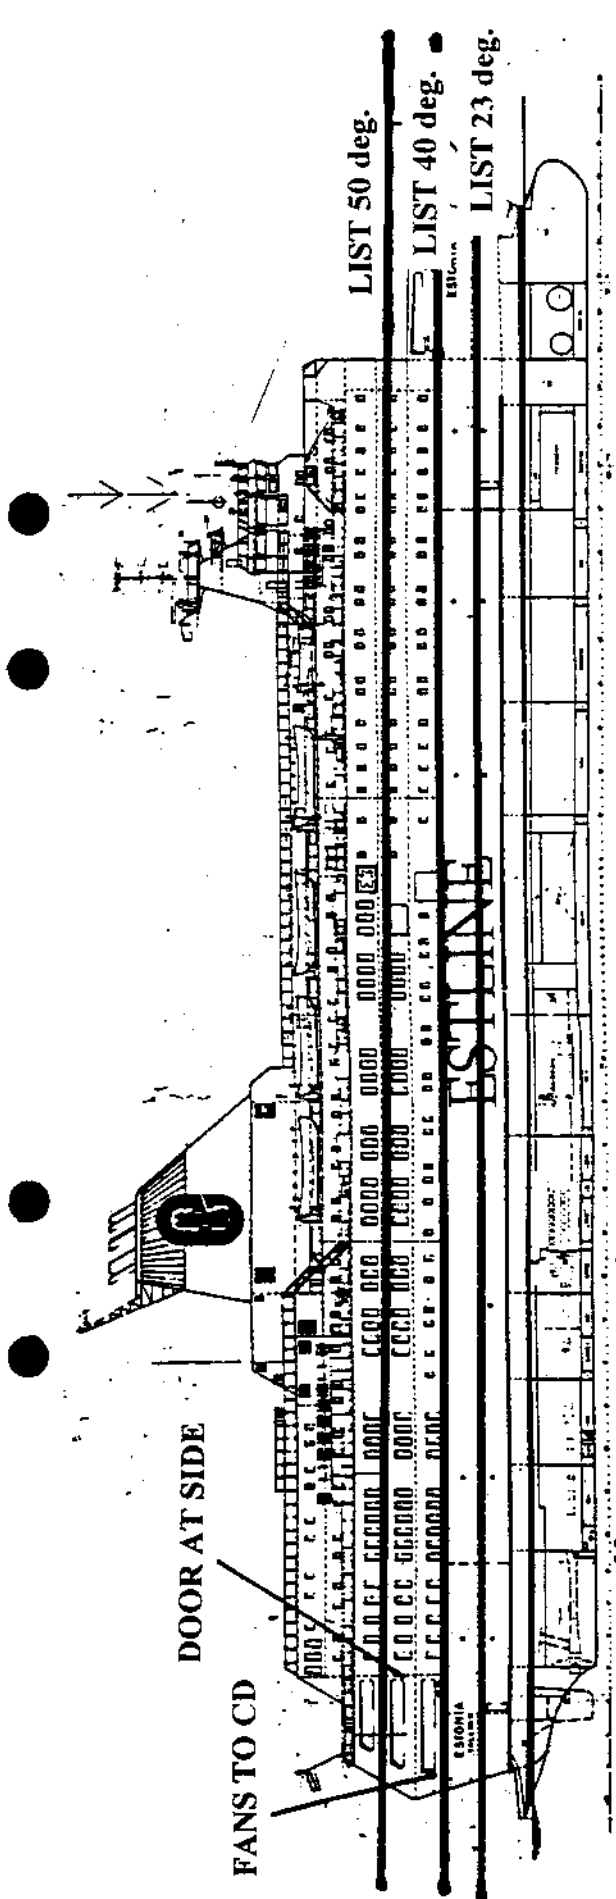
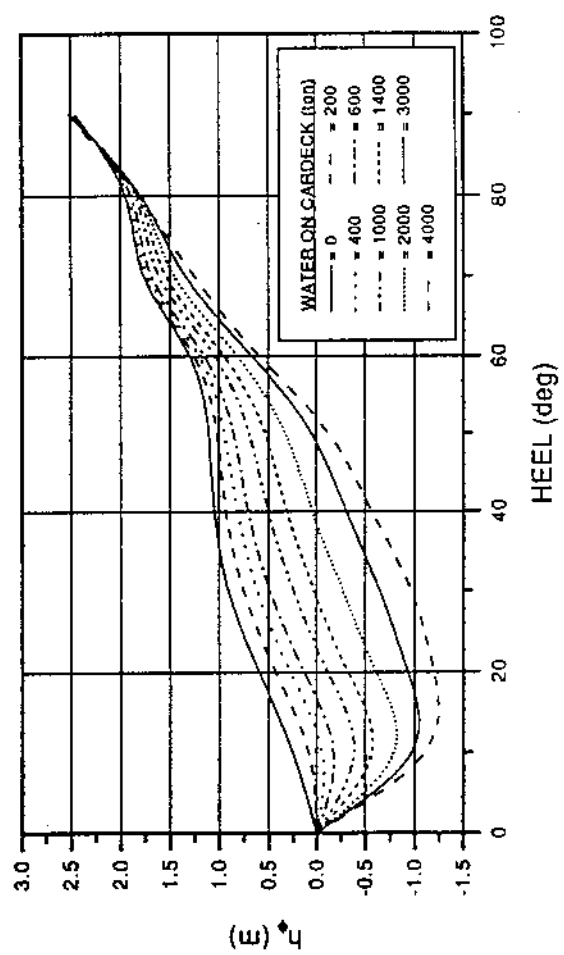
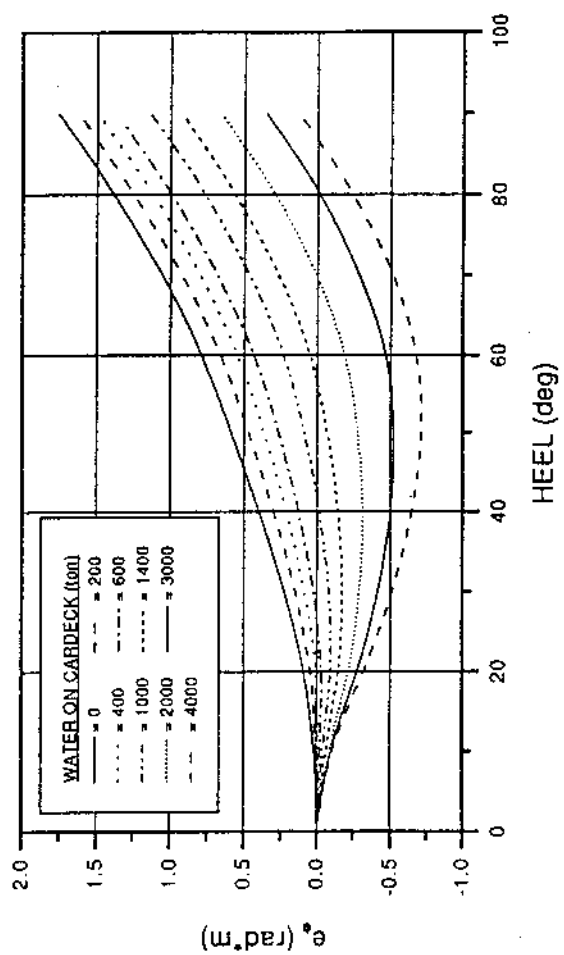
SITUATION AT ABOUT 0135 hrs WHEN THE CLOCK ON THE BRIDGE 3 m TO SB FROM CL STOPPED AND SURVIVORS WERE WASHED AND JUMPING TO SEA
